The City of Baltimore Loch Raven Dam Rehabilitation Project Update: November, 2004

Over 83,000 Safe Hours Logged

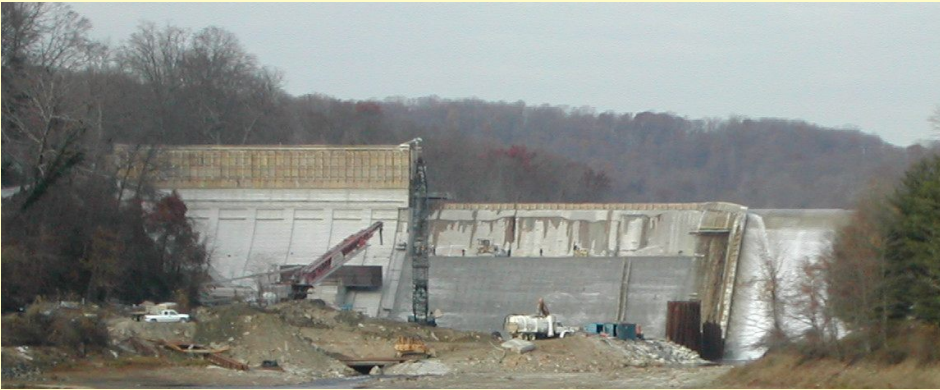
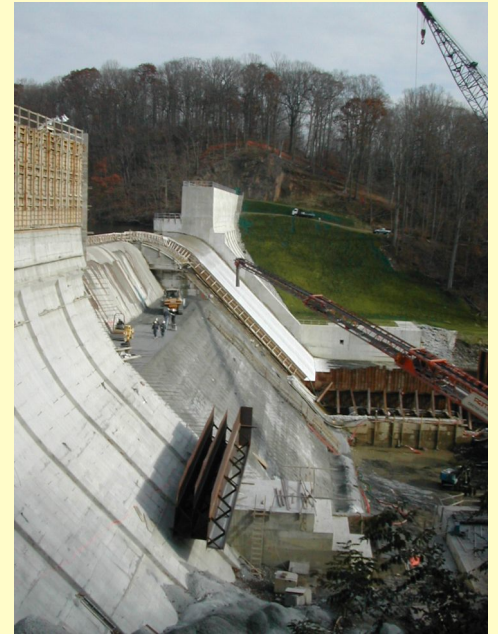
Don't blink!!! The west side RCC placement is nearly complete!!! All rock anchors are now installed, and the west side stilling basin is ready for RCC.

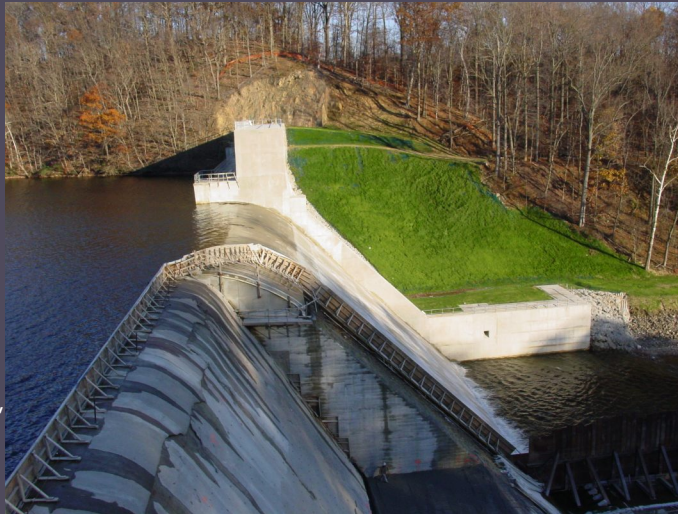
Since January, 2003, water has been cresting the dam. With the east side buttoned up, and in order for the contractor to begin operations on the west side spillway, the bulkhead on the east side was dismantled, and re-built on the west side.

To accomplish this, the reservoir had to be lowered 3 feet. Rains quickly refilled the reservoir, and the bulkhead went right to work!

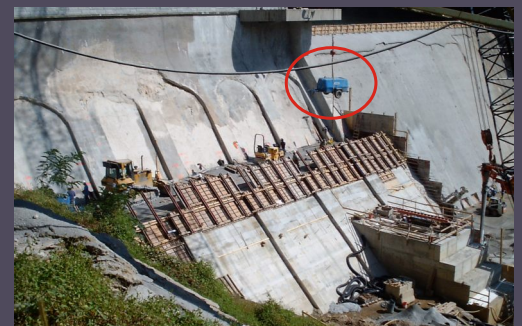
As RCC placement climbs, so too must the contractor's equipment. Cranes, coordination, and "safety first" keep the work area moving up.

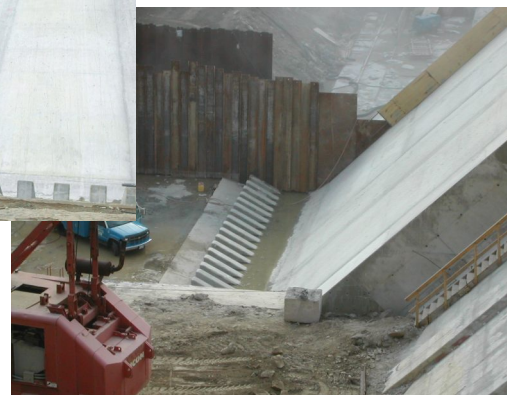
Within the roller bucket, large protrusions, or teeth, act to diminish the energy in the water and debris that fall down the spillway. This adds protection to the lower pool, by reducing erosion and damage that fast-moving currents and objects can cause.
